CULTURAL LANDSCAPE REPORT
FOR THE SANDY HOOK
COASTAL DEFENSE BATTERIES
GATEWAY NATIONAL RECREATION AREA

CULTURAL LANDSCAPE REPORT FOR THE SANDY HOOK COASTAL DEFENSE BATTERIES

GATEWAY NATIONAL RECREATION AREA

FORT HANCOCK, NEW JERSEY

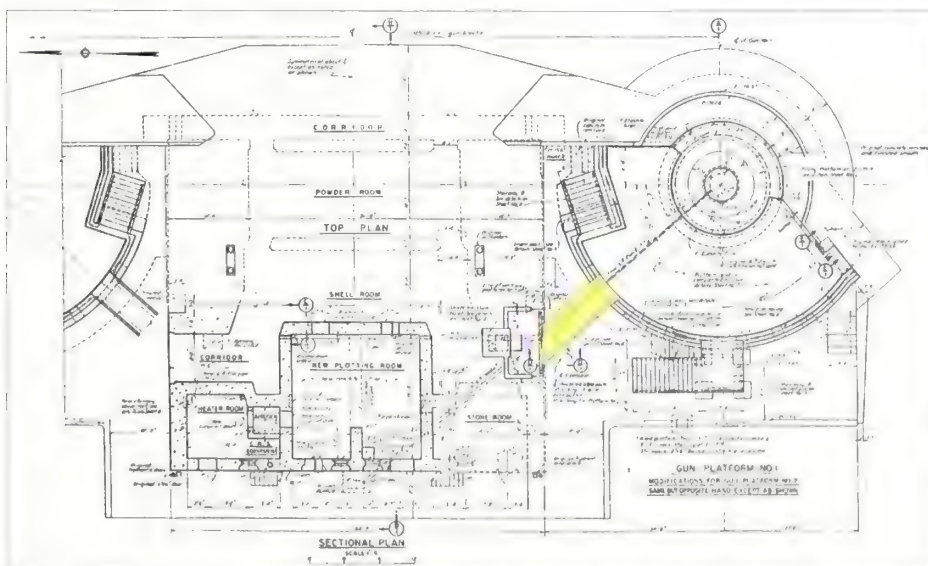
Figure 2.122. Detail of Harbor Defenses of New York, Battery Gunnison, Alterations and Additions, Fort Hancock, New Jersey, 1943. In 2001, the park demolished a concrete bridge (highlighted in yellow) at Battery Gunnison in order to eliminate hazards created by the deteriorating concrete. The bridge spanned between the south gun platform and the shell hoist (GATE 10689).

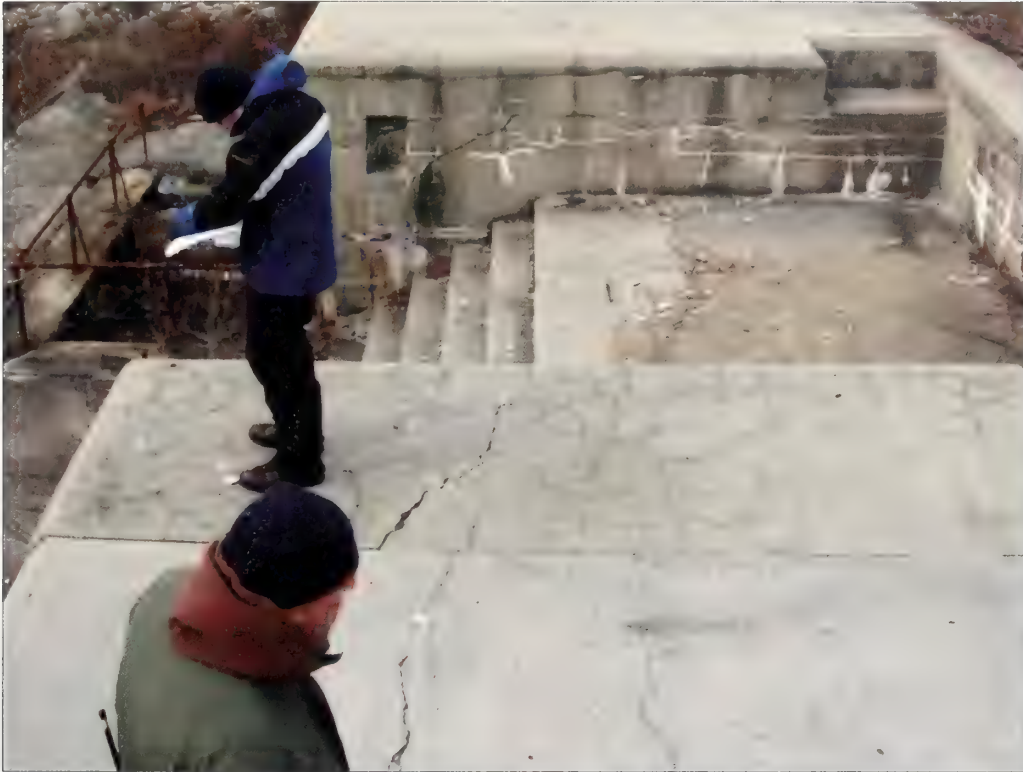
Efflorescence can be seen on many of the vertical concrete surfaces indicating water has penetrated the concrete and is drawing out salts and other impurities to the surface (see Figure 3.1). Spalling surfaces are present in the gun platforms and the tops of the magazines have substantial cracks. Guardrails are located at stairwells leading to the magazines and a handrail is installed along an external set of stairs leading to the battery commander's station. Both types of railings show a heavy degree of corrosion and are staining the concrete below them. Access to existing doors is blocked by vegetation that has grown up in the stairwells (Figure 3.2).

Figure 3.1. View looking west at gun platform #5, Battery Urmston. The gun platforms for emplacements #1, #2, #5, and #6 are T-shaped with full-width steps that lead up the long leg of the "T." At the north end of the platforms, narrow notches served as a recessed space to rest pillar mounted guns when not in use (Olmsted Center, January 2009).

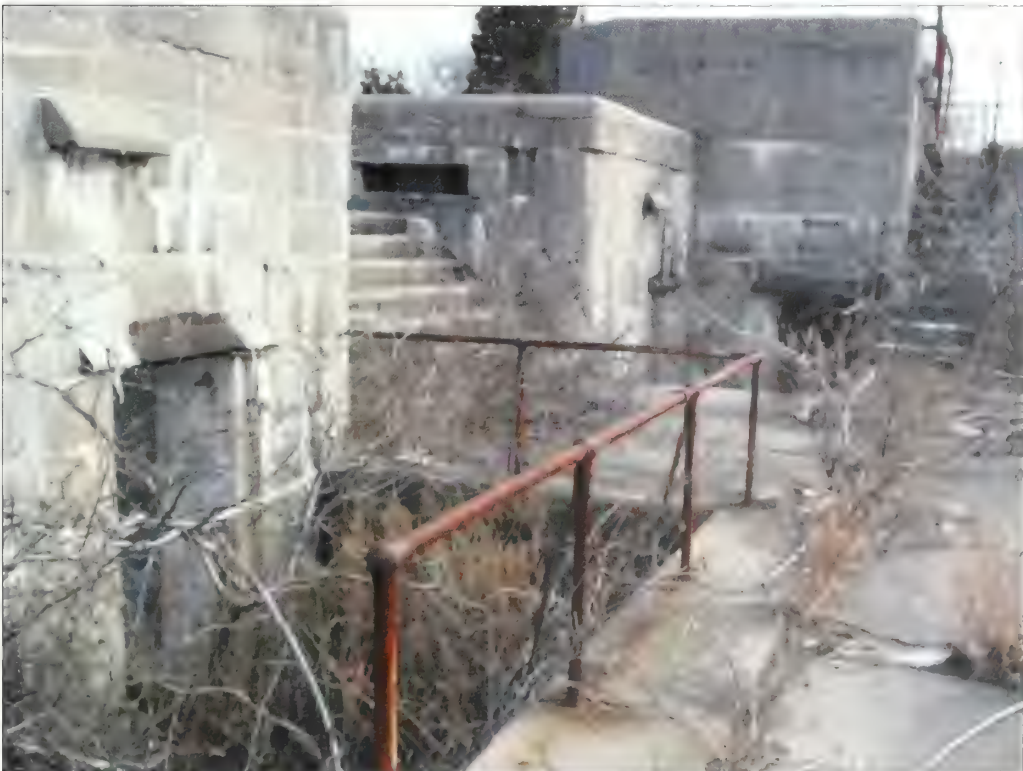
Figure 3.2. View looking northeast at stairwells to magazines, Battery Urmston. Both handrails and guardrails show a heavy degree of corrosion and are staining the concrete below them. Access to existing doors is blocked by vegetation that has grown up in the stairwells (Olmsted Center, January 2009).

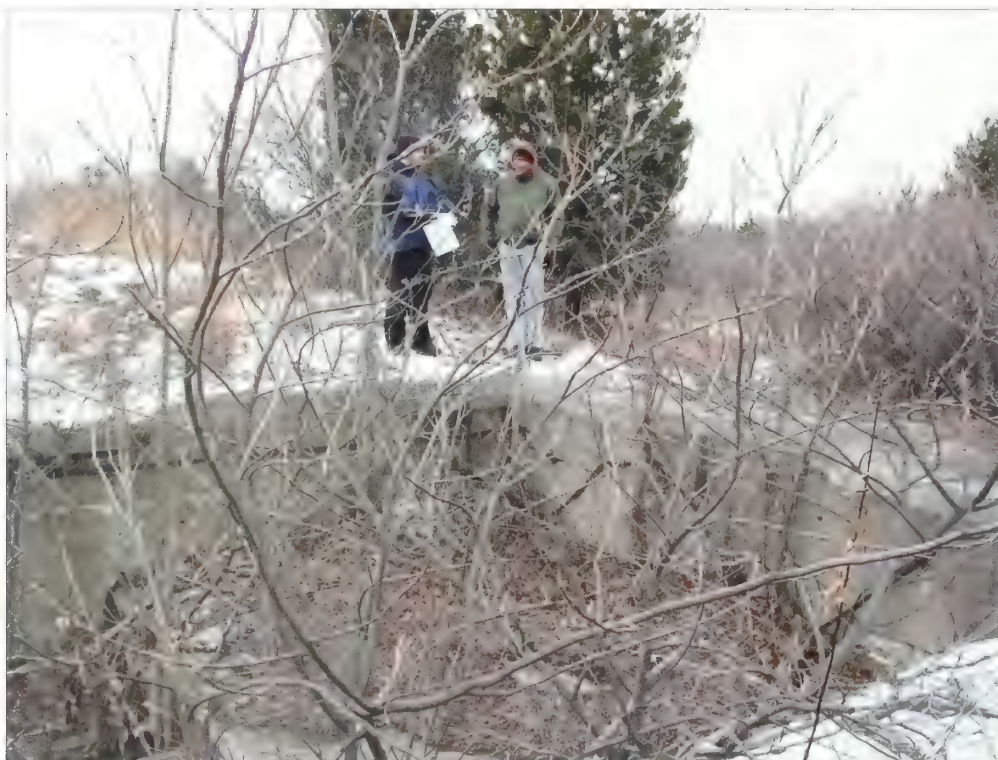
In a triangular area between the Coast Guard perimeter fence and battery, ailanthus (*Ailanthus altissima*), Virginia creeper (*Parthenocissus quinquefolia*), poison ivy (*Toxicodendron radicans*), and honey locust saplings (*Gleditsia triacanthos*) overrun the space and result in limited pedestrian access. On the north-facing engineered slope of Battery Urmston, large woody vegetation primarily consists of eastern red cedar (*Juniperus virginiana*), beach plum (*Prunus maritima*), hackberry (*Celtis occidentalis*), and ailanthus (*Ailanthus altissima*). These species have also found suitable locations to grow in the low-lying areas, flat surfaces, and cracks of the battery (Figure 3.3).

Figure 3.3. View looking northwest at gun platform #3, Battery Urmston. Large woody vegetation primarily consists of eastern red cedar (*Juniperus virginiana*), beach plum (*Prunus maritima*), hackberry (*Celtis occidentalis*), and ailanthus (*Ailanthus altissima*). These species have also found suitable locations to grow in the low-lying areas, flat surfaces, and cracks of the battery (Olmsted Center, January 2009).

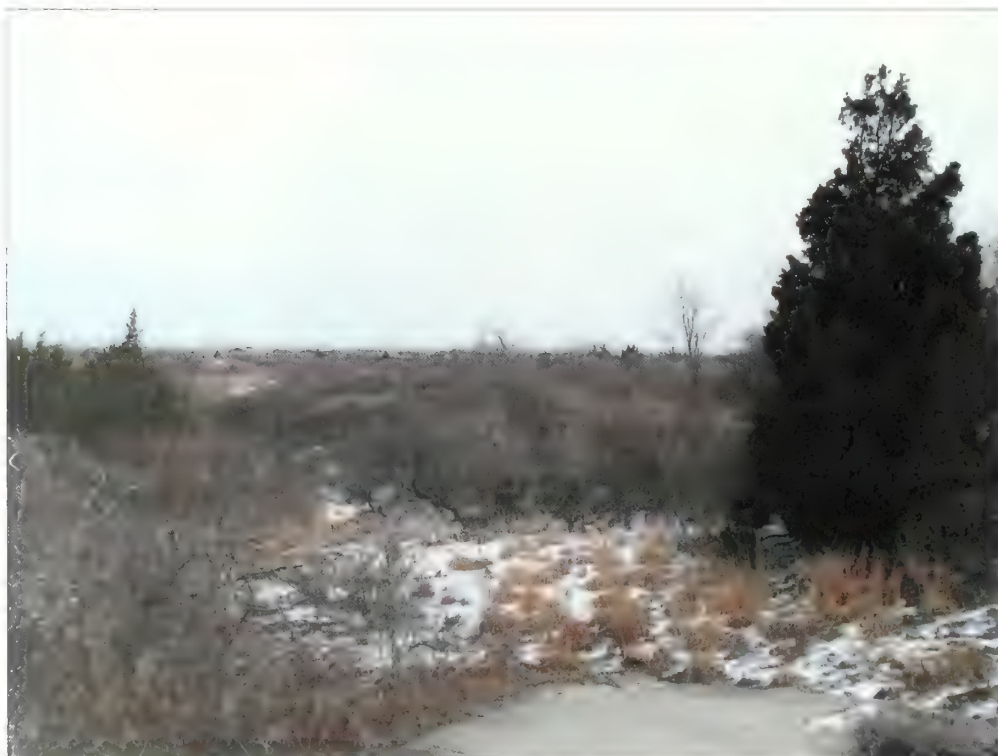
The views from the gun platforms and battery commander's station to the water are primarily impeded by woody vegetation growing at the interface of the engineered slope and concrete battery structure (Figure 3.4). It is difficult to evaluate the impact on views beyond these immediate vegetative obstructions. In general, there appears to be minimal tall vegetation beyond the engineered slope and no additional buildings or structures. At the eastern end of the Battery Urmston, there is an engineered earthwork that rises up between the battery and Battery Morris. The earthwork ends abruptly at a concrete retaining wall that extends from Urmston. Immediately east of the retaining wall, a four-foot high, wood-slat fence meanders up the earthwork and wraps around toward the gun platform. The fence is painted maroon red and is in fair condition.

Figure 3.4. View looking northeast from gun platform #4, Battery Urmston. The views from the gun platforms and battery commander's station to the water are primarily impeded by woody vegetation growing at the interface of the engineered slope and concrete battery structure (Olmsted Center, January 2009).

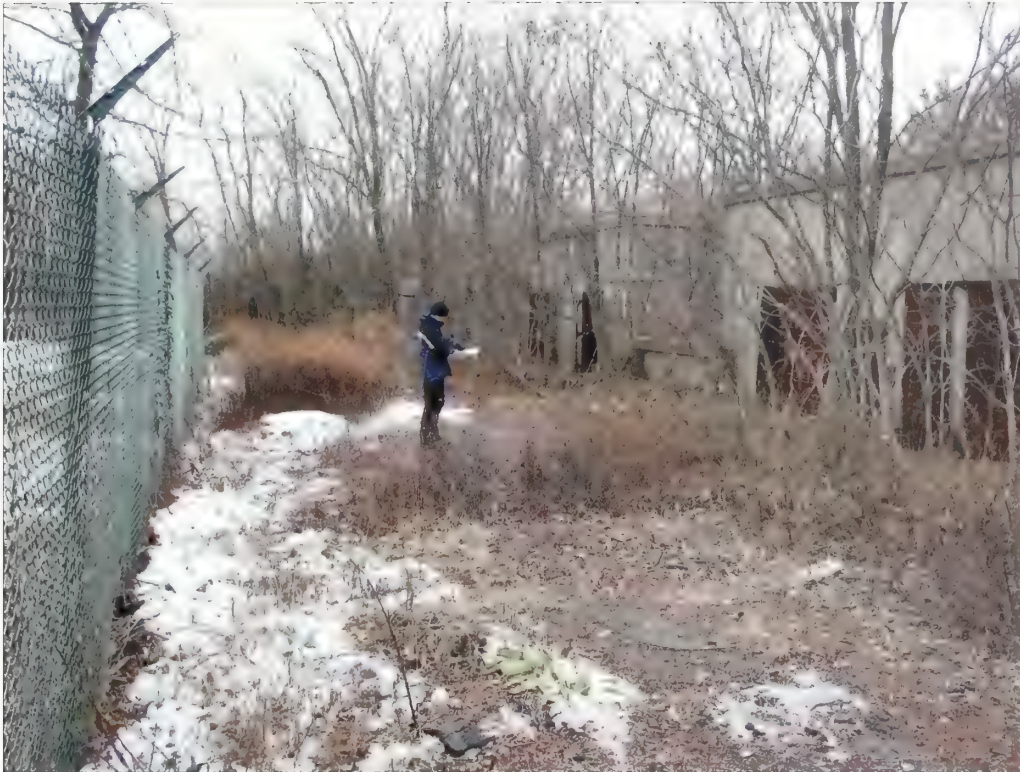
There is currently no vehicular access to Battery Morris and visitors wishing to see the structure have to walk west from Nine Gun Battery and Battery Peck to access a trail that leads to the structure. The trail has a variable width and is a remnant of North Bragg Drive. The trail surface is comprised of broken asphalt and accumulated leaf litter and debris. Emerging woody vegetation obscures a clear definition of the trail and makes pedestrian access difficult (Figure 3.5).

Figure 3.5. View looking west at U.S. Coast Guard perimeter fence and Battery Morris. There is currently no vehicular access to Battery Morris and staff and visitors wishing to see the structure walk on a trail surface comprised of broken asphalt and accumulated leaf litter and debris. Emerging woody vegetation obscures a clear definition of the trail and makes access difficult (Olmsted Center, January 2009).

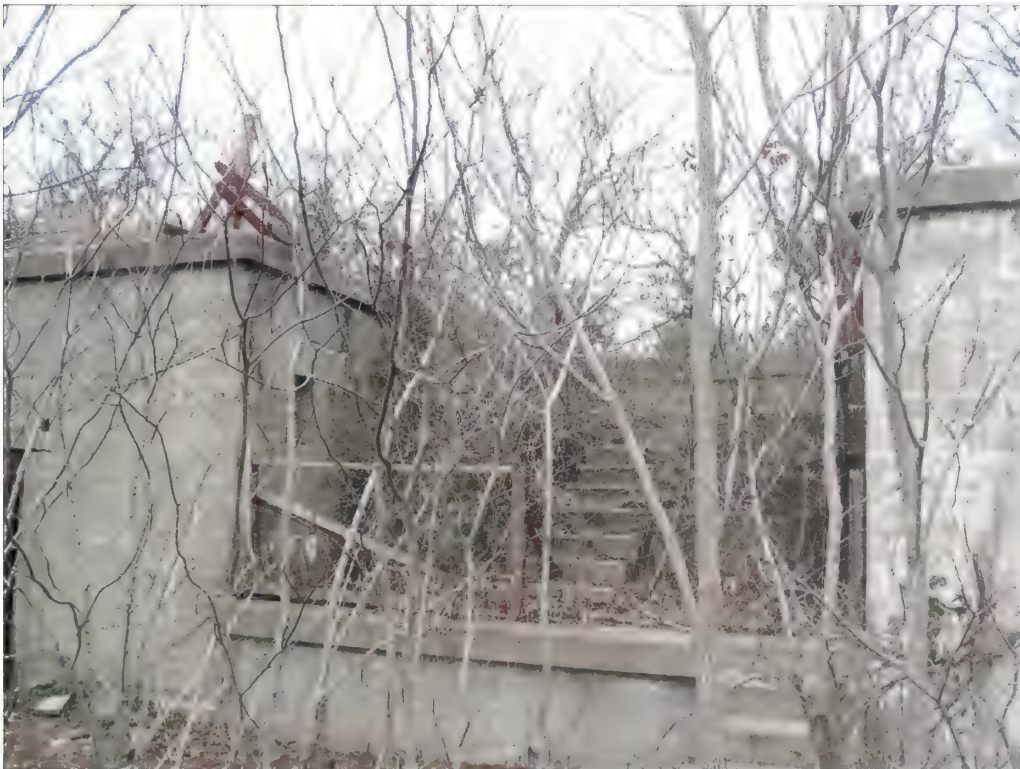
Figure 3.6. View looking north at emplacement #2, Battery Morris. Woody vegetation is growing in and around the stairs to the point where they are difficult to ascend and reach the gun platforms (Olmsted Center, January 2009).

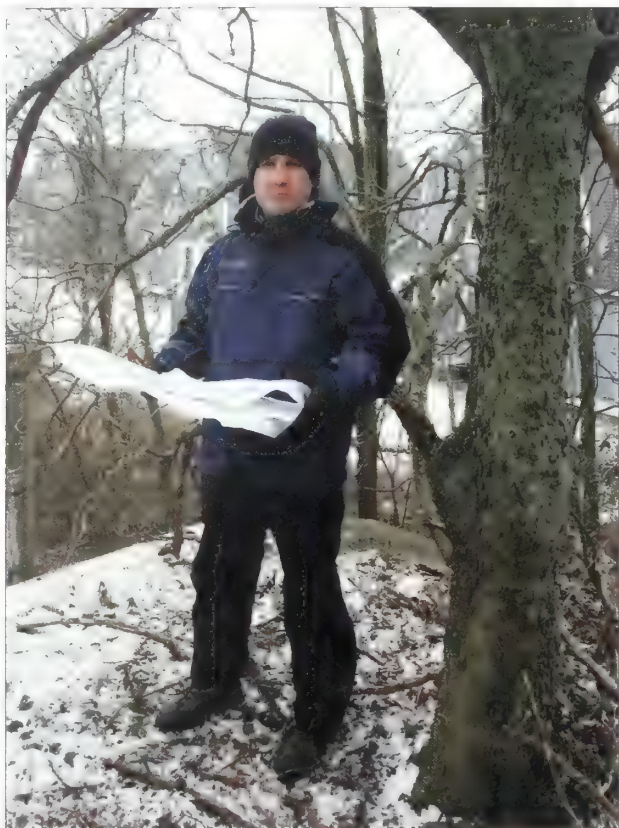
virginiana), black locust (*Robinia pseudoacacia*), beach plum (*Prunus maritima*), hackberry (*Celtis occidentalis*), and ailanthus (*Ailanthus altissima*). A large hackberry, approximately eighteen-inches diameter at breast height, is growing on the battery to the west of gun platform #4 (Figure 3.7). In addition to the large woody species, there appears to be greater quantities of Japanese honeysuckle (*Lonicera japonica*) and Asiatic bittersweet (*Celastrus orbiculatus*) growing on the engineered earthwork of Battery Morris than at nearby Battery Urmston. Vegetation completely surrounds the CRF and the plant material is dense enough that identifying the elevated structure from the access trail is difficult.

Figure 3.7. View looking southeast, Battery Morris. A large hackberry, approximately eighteen-inches diameter at breast height, is growing on the battery to the west of gun platform #4 (Olmsted Center, January 2009).

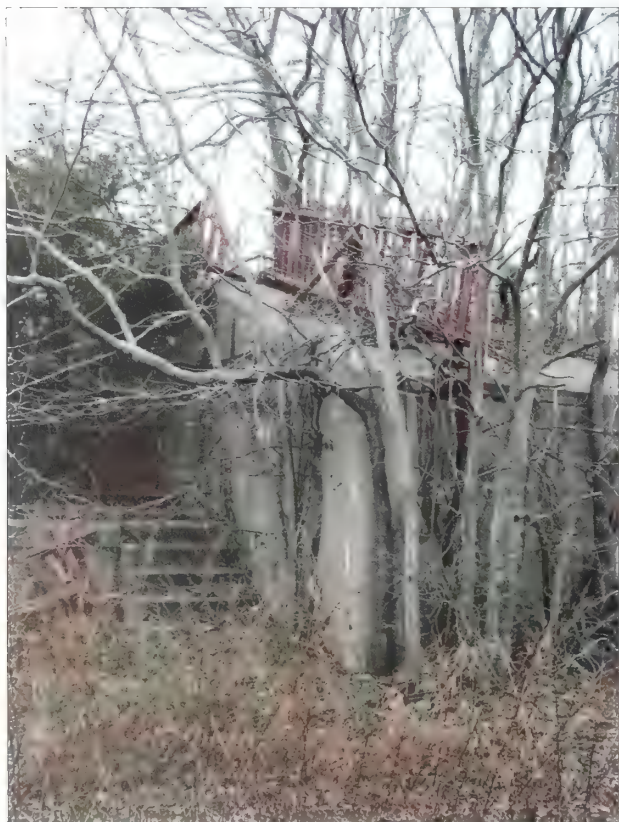
The downrange views from Battery Morris to the water are primarily impacted by vegetation growing at the interface of the engineered earthwork and concrete battery structure. North of the engineered earthwork, vegetation growing on the north slope of a swale may obstruct views as well. Vegetation immediately north of the CRF blocks any views to the water. At gun platforms #1 and #2, wood two-by-four guard panels are installed and are in poor condition (see Figure 3.6). Similar to the wood guard panels, a wood picket fence is located to the north and east of gun platform #1 (Figure 3.8). The fence is painted maroon red and is also in poor condition.

Figure 3.8. View looking northeast at gun platform #1, Battery Morris. A wood picket fence is located to the north and east of the gun platform that is painted maroon red and is in poor condition (Olmsted Center, January 2009).

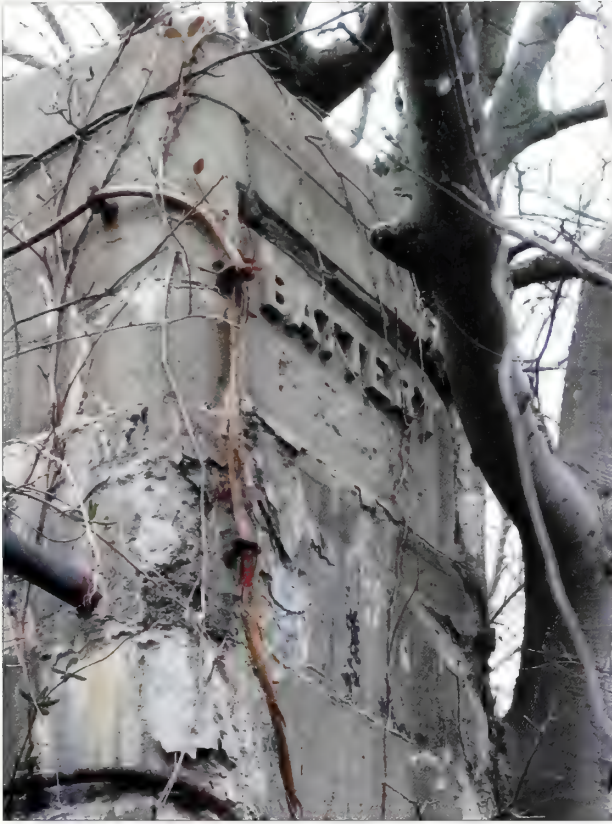
Figure 3.9. View looking northeast at corner of structure, Battery Peck. Efflorescence can be seen on many of the vertical surfaces and spalling is present on both horizontal and vertical surfaces indicating water has penetrated the concrete and is damaging the material (Olmsted Center, January 2009).

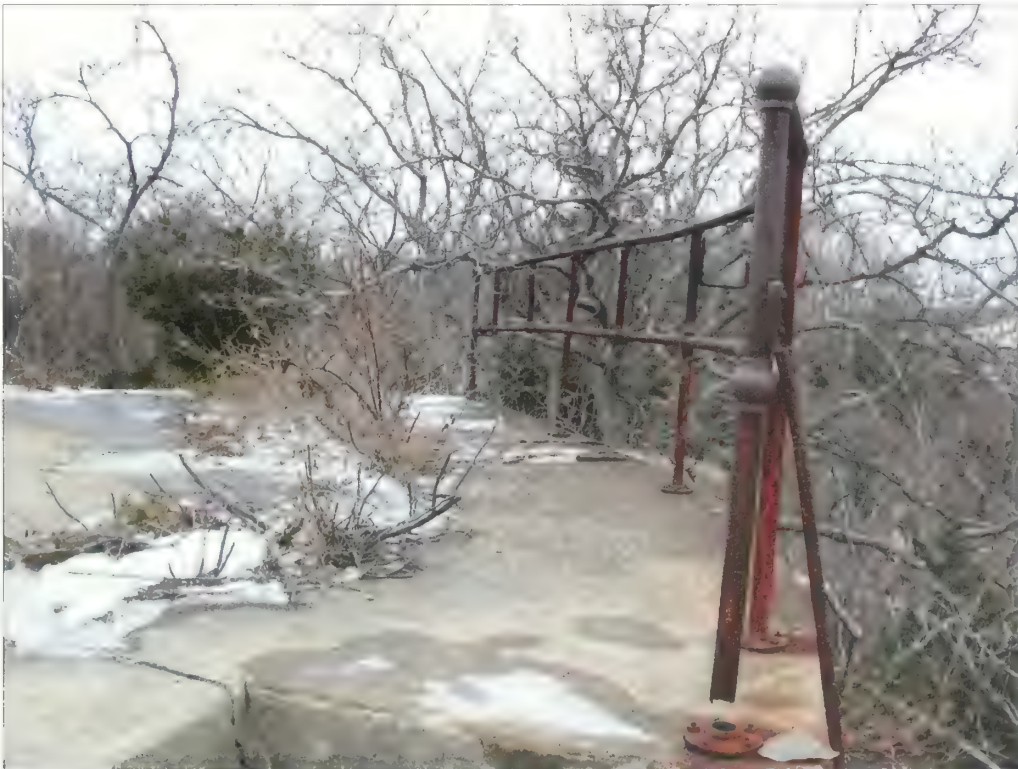
Battery Peck consists of two circular gun platforms, a covered concrete commander's station, and magazines accessed from the ground level on the south side of the structure. From the ground level, a three sets of concrete steps lead up to an intermediate level. A set of steps is located at the west end, the east end, and in the center of the structure. Additional steps, one set for each platform, lead from the intermediate level to the former gun emplacements. Each platform is roughly forty feet in diameter, however, it is difficult to discern the full extent of the concrete structure due to accumulated sand and vegetation. Approximately 110 feet separate the two gun platforms. The battery commander's station is centered between two platforms and a tall metal pole is attached with metal brackets to the east side of the structure. Efflorescence can be seen on many of the vertical surfaces and spalling is present on both horizontal and vertical surfaces (Figure 3.9). Handrails and guardrails are located along steps and intermediate level leading to the gun platforms. The railings are in fair to poor condition with corrosion covering most pieces. Some assemblies lack any solid material where the vertical members fasten the railing to a solid support (Figure 3.10).

Figure 3.10. View of guardrail south of emplacement #1, Battery Peck. The railings are in fair to poor condition with corrosion covering most pieces. Some assemblies lack any solid material where the vertical members fasten the railing to a solid support (Olmsted Center, January 2009).

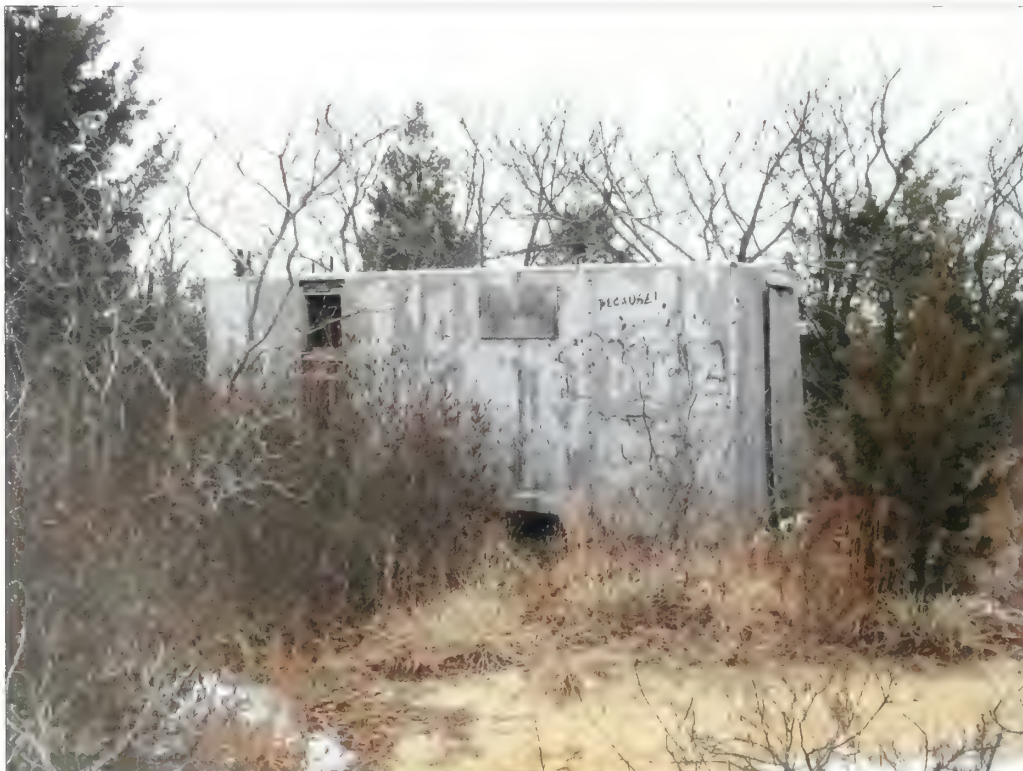
Figure 3.12. View looking north at a post World War II trailer, Batteries Engle and Peck. Northeast of Battery Engle, a communications trailer sits abandoned. The trailer is a frequent target for graffiti (Olmsted Center, January 2009).

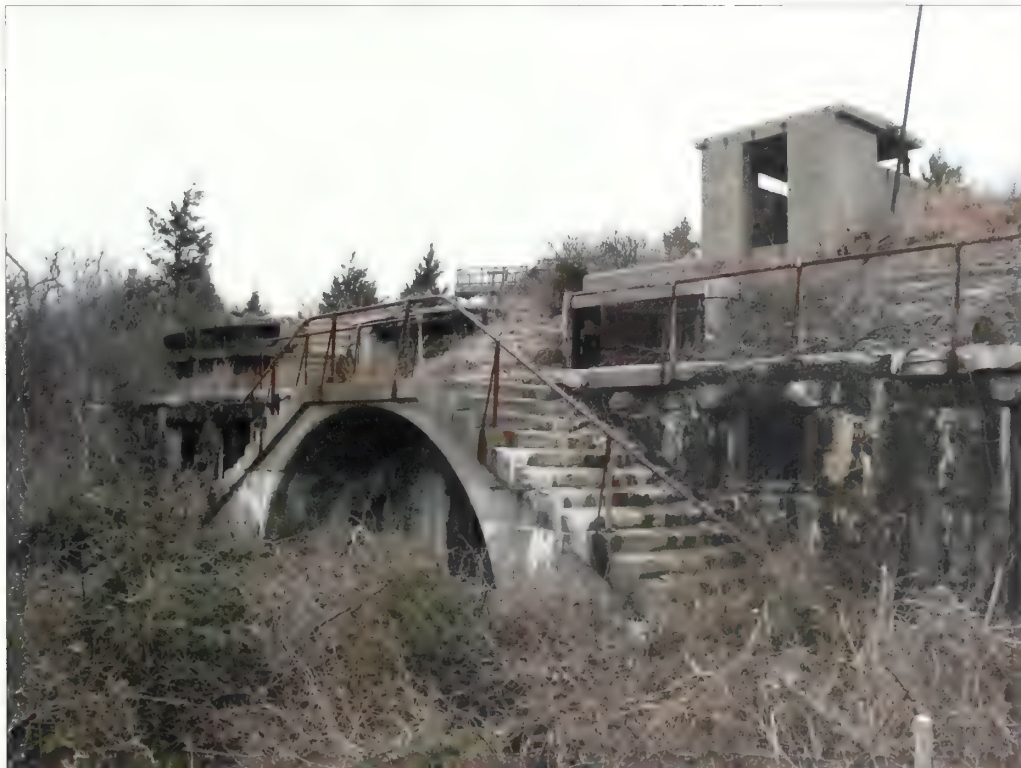
Figure 3.14. View looking northwest at Battery Peck. Presently, the area south of Battery Peck is filled with dense vegetation and is nearly impassable (Olmsted Center, January 2009).

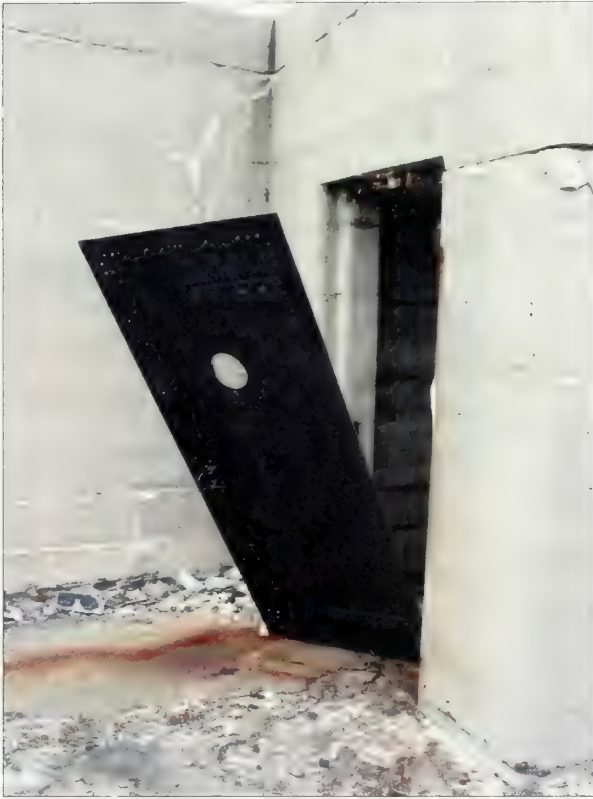
Several dozen doors and windows are missing or not properly mounted at the magazines, commander's stations, and other auxiliary rooms at Nine Gun Battery (Figure 3.17). A cantilevered structure between emplacements #5 and #7, intended to provide access to the battery commander's station, is in poor condition (Figure 3.18). Both handrails and guardrails are present at Nine Gun Battery and are generally in good to fair condition (Figure 3.19). At transitions between the ground level and gun platforms and also the gun platforms and terreplein, there are stairs and ramps that lack any kind of railing (Figure 3.20).

Figure 3.17. View of failing metal door, Nine Gun Battery. Several dozen doors and windows are missing or not properly mounted at the magazines, commander's stations, and other auxiliary rooms at Nine Gun Battery (Olmsted Center, January 2009).

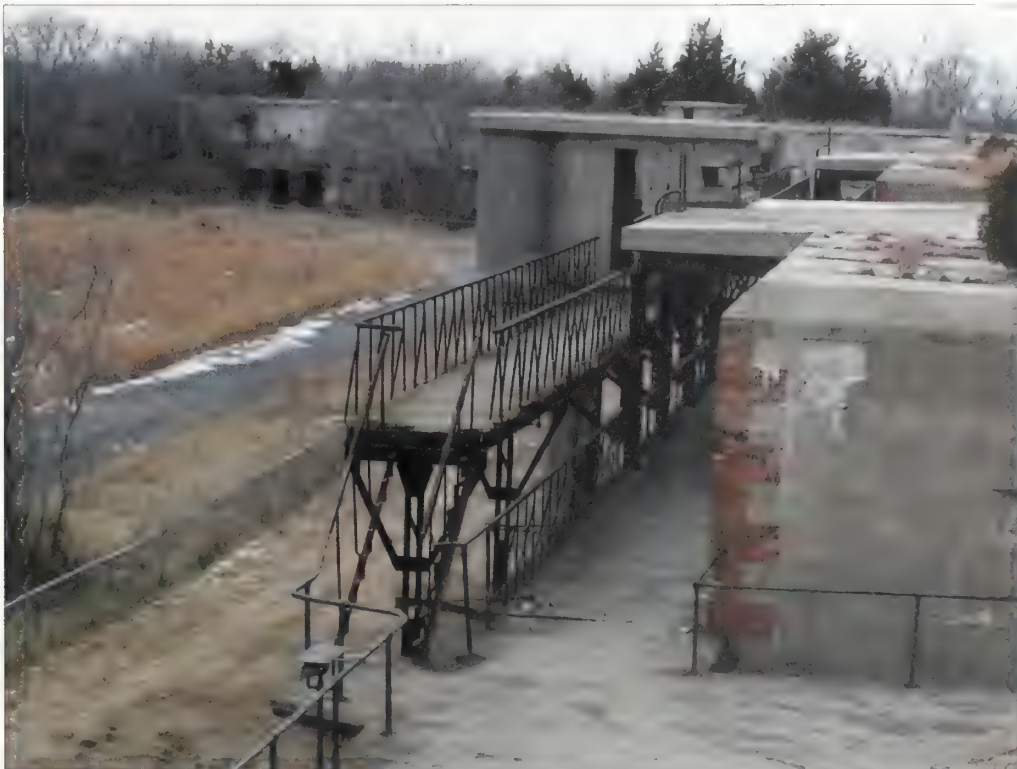
Figure 3.18. View looking west at battery commander's station Halleck, Nine Gun Battery. A cantilevered structure between emplacements #5 and #7, intended to provide access to the commander's station, is in poor condition (Olmsted Center, January 2009).

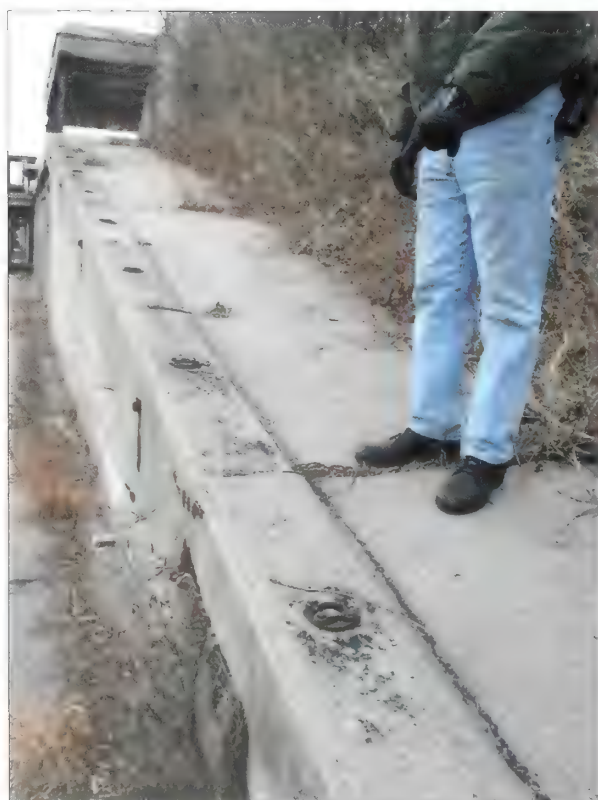
Figure 3.20. View looking northwest at the concrete ramp to gun platform #1, Nine Gun Battery. At transitions between the ground level and gun platforms and also the gun platforms and terreplein, there are stairs and ramps that lack any kind of railing. This ramp has escutcheon plates but lacks a guardrail (Olmsted Center, January 2009).

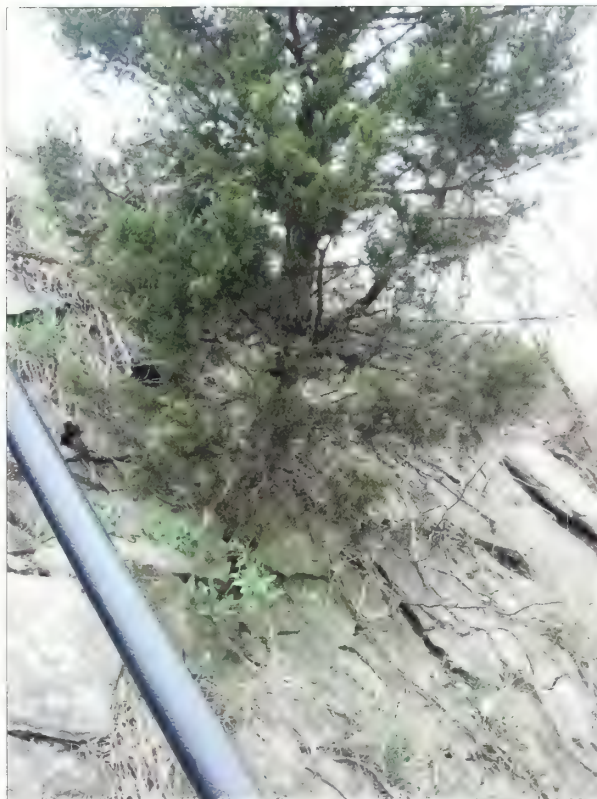
Figure 3.33. View looking east from access stairs, Battery Potter. The sloped portion of the concrete battery, rising approximately ten-feet above the engineered earthwork, has eastern red cedars (*Juniperus virginiana*) growing in cracks and in large spalling areas (Olmsted Center, April 2008).

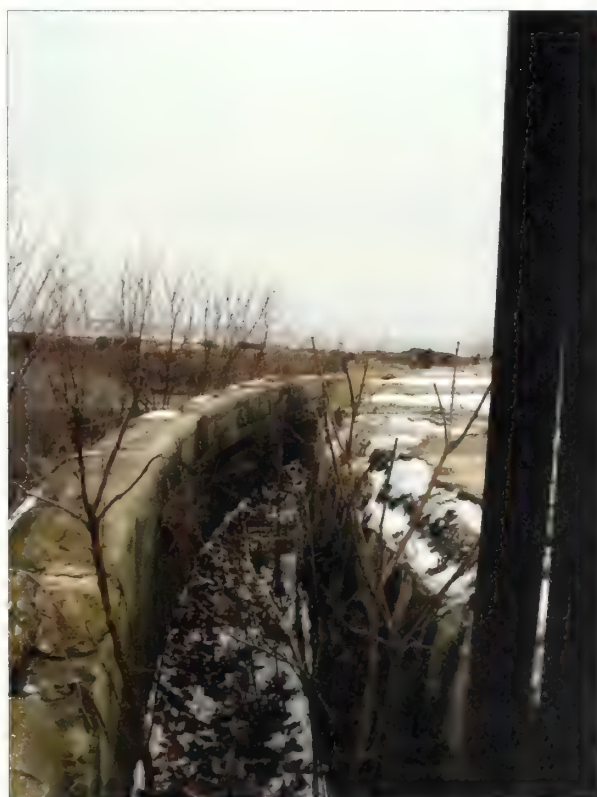
Figure 3.34. View looking east at the *chemin de ronde*, Battery Potter. The *chemin de ronde* is presently a collection area for leaf litter and debris that supports the growth of woody vegetation (Olmsted Center, January 2009).

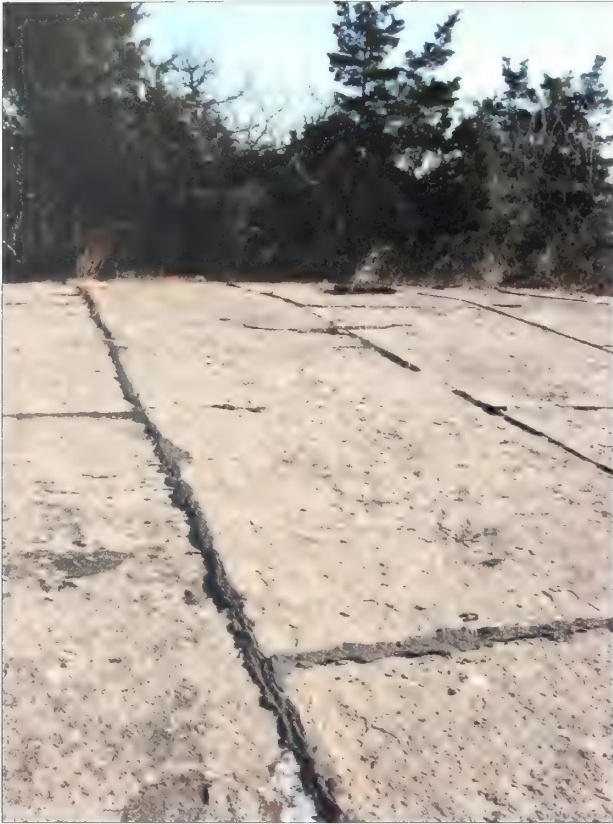
Figure 3.35. Close-up view of concrete terreplein, Battery Granger. The concrete terreplein shows evidence of an asphalt-based product either used to fill joints or remaining in the joints after use as part of a larger concrete surface treatment (Olmsted Center, January 2009).

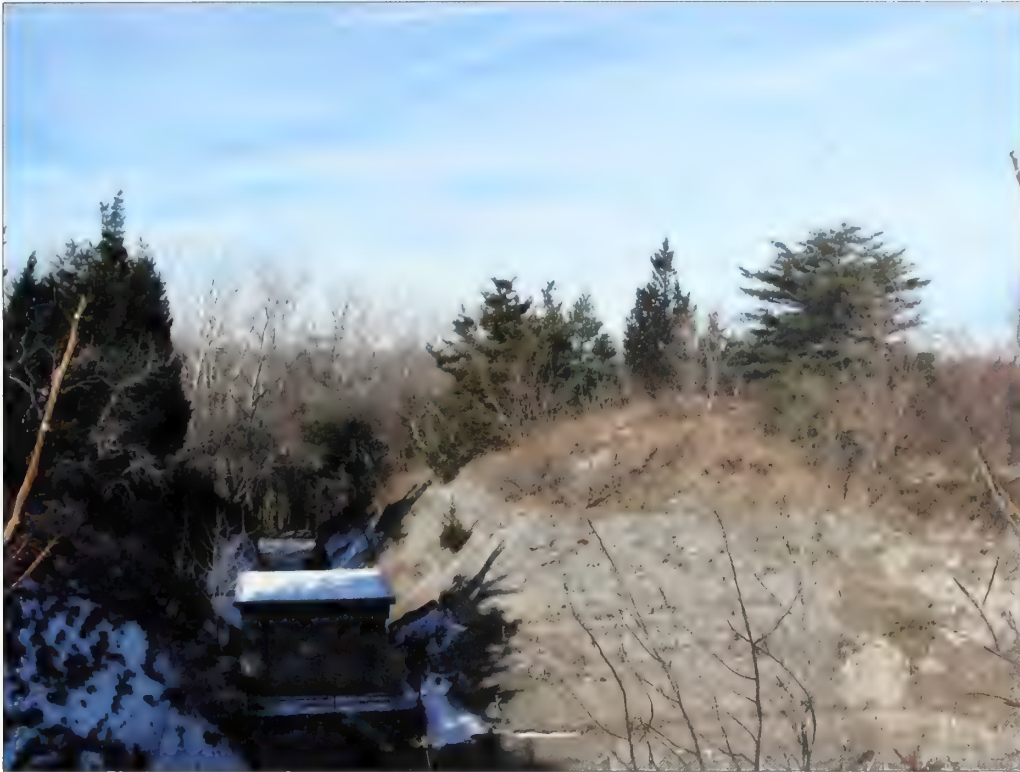
Figure 3.37. View looking west across southwest mortar pit, the Mortar Battery. Efflorescence and spalling are present on the concrete blast slope above the mortar pit. These symptoms of water infiltrating concrete can be seen on additional horizontal and vertical concrete surfaces at the Mortar Battery (Olmsted Center, January 2009).

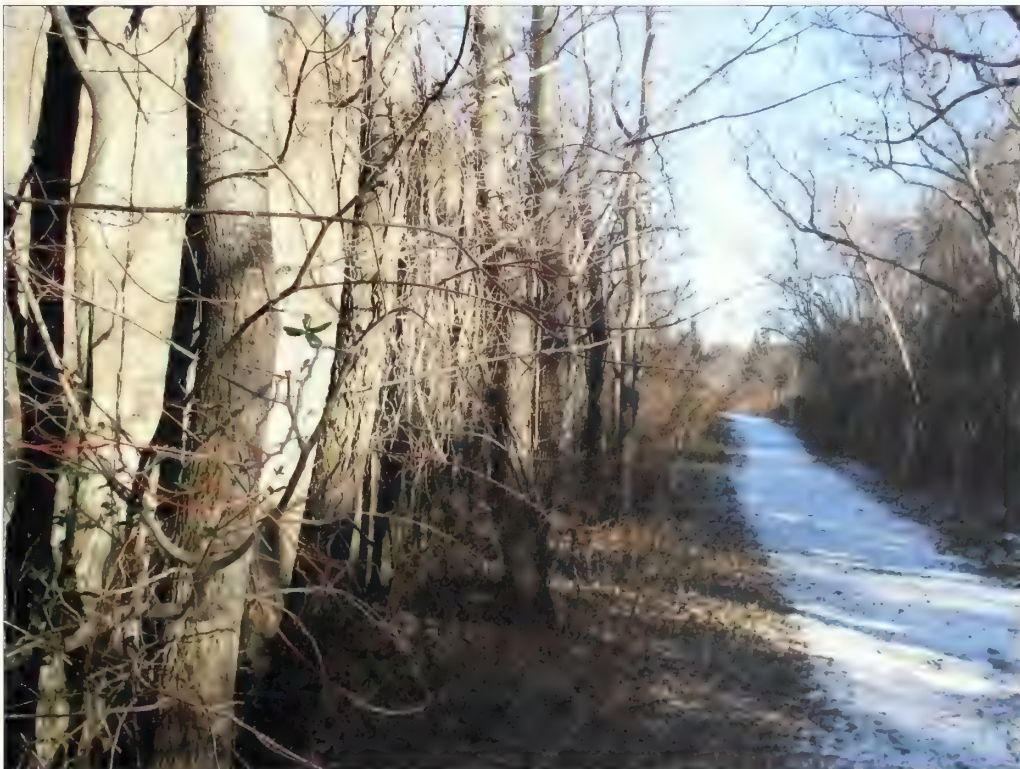
Figure 3.38. View looking north along perimeter wall, the Mortar Battery. Large woody vegetation is growing between the perimeter wall and the trail to the northwest and southwest emplacements. The main species along the perimeter wall is hackberry (*Celtis occidentalis*) (Olmsted Center, January 2009).

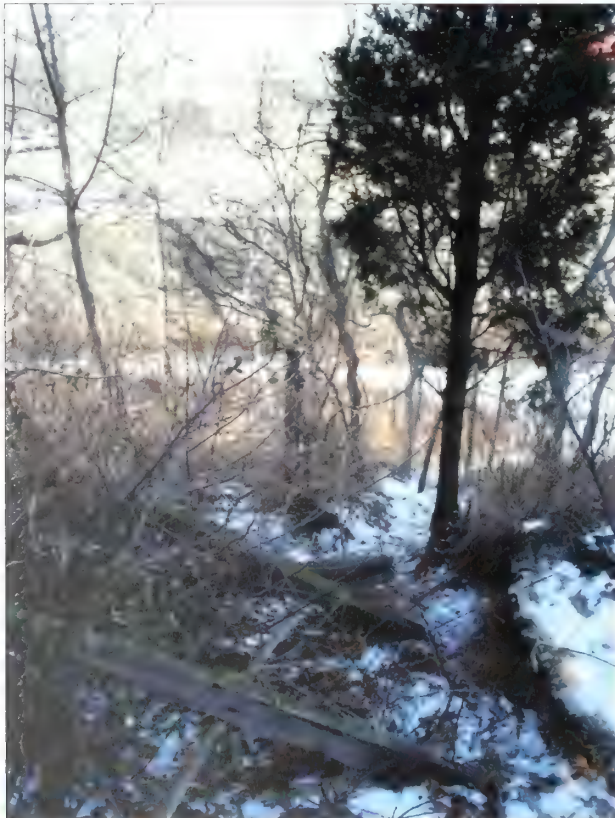
Figure 3.40. View near top of southwest mortar pit, the Mortar Battery. At the top of the Mortar Battery, several wood post and wire cable fences are installed that are in fair to poor condition (Olmsted Center, January 2009).

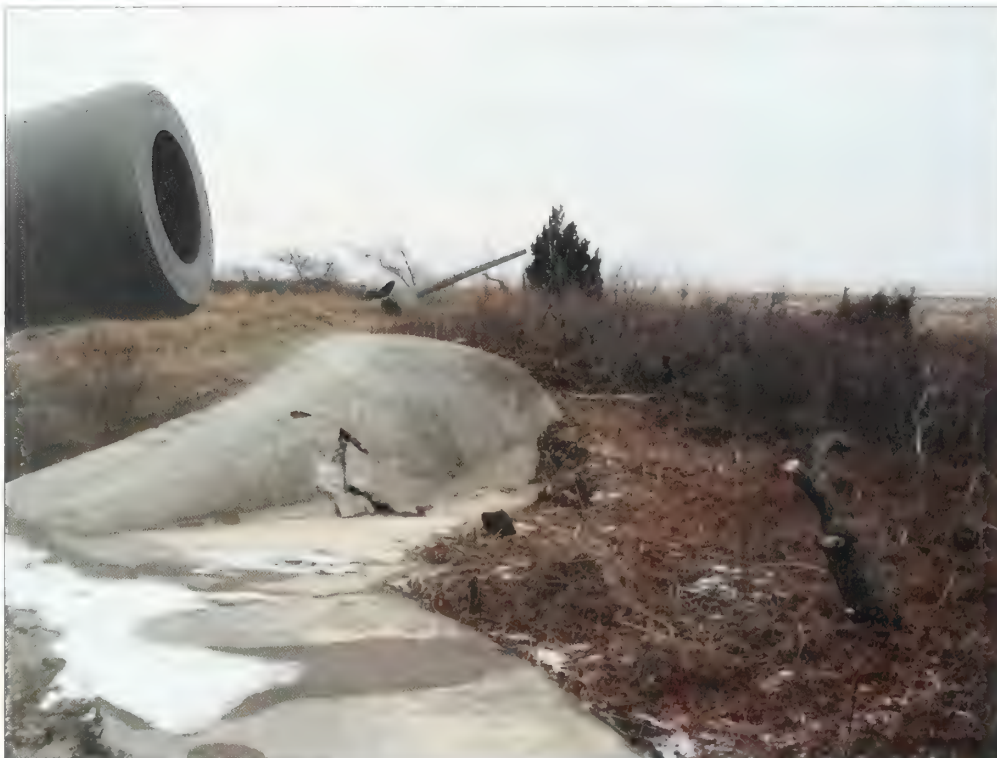
Figure 3.43. View looking north from emplacement #1 to emplacement #2, Battery Gunnison. Spalling is present on a concrete feature due to infiltration of water and freeze-thaw cycles (Olmsted Center, January 2009).

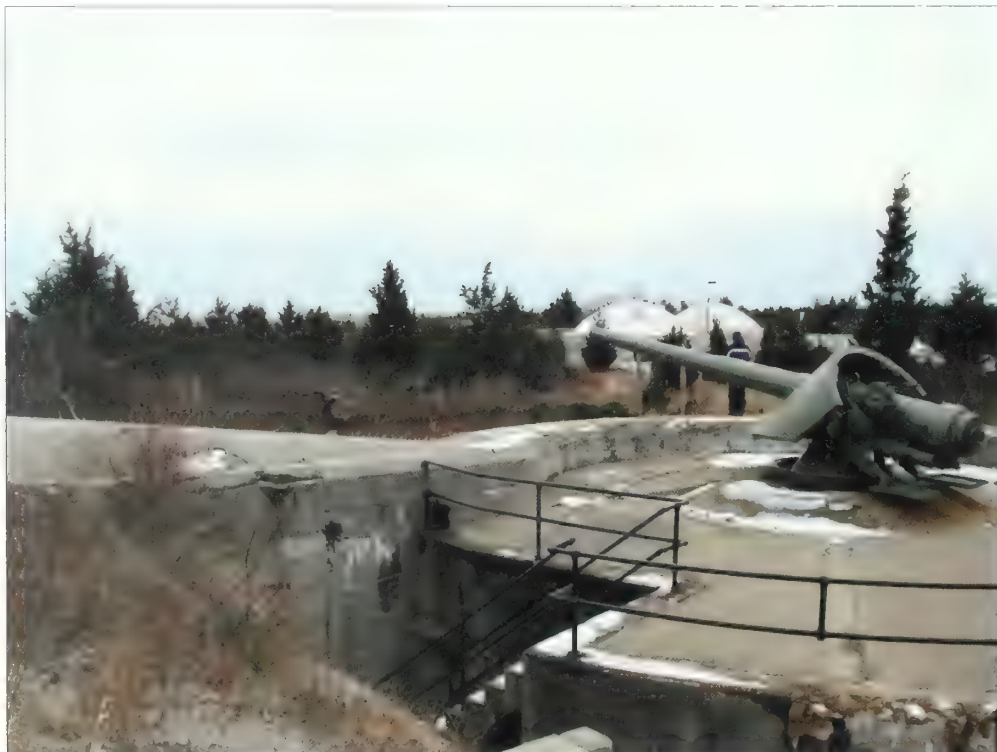
Figure 3.44. View looking southeast at emplacement #2, Battery Gunnison. The vegetation on Battery Gunnison's engineered slopes is primarily eastern red cedar (*Juniperus virginiana*) and beach plum (*Prunus maritima*) (Olmsted Center, January 2009).

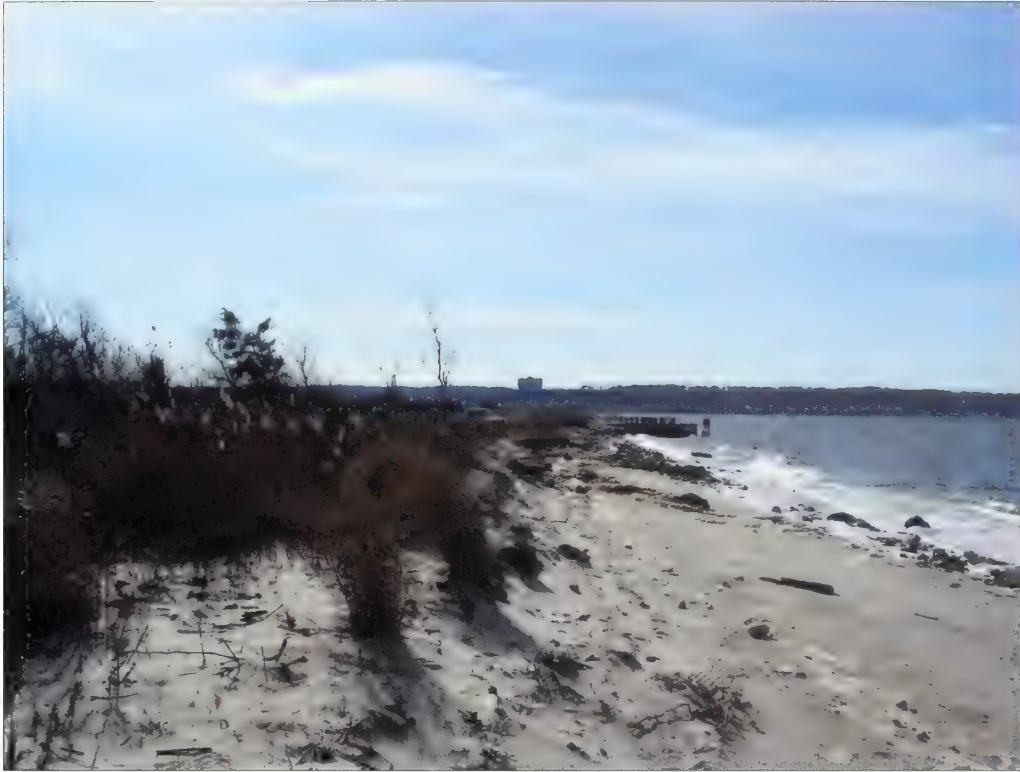
Figure 3.45. View looking south at eroded vehicular route, Battery Mills. On the west side of Battery Mills a portion of the road encircling the battery, approximately 200-feet, has been washed away by Sandy Hook Bay (Olmsted Center, January 2009).

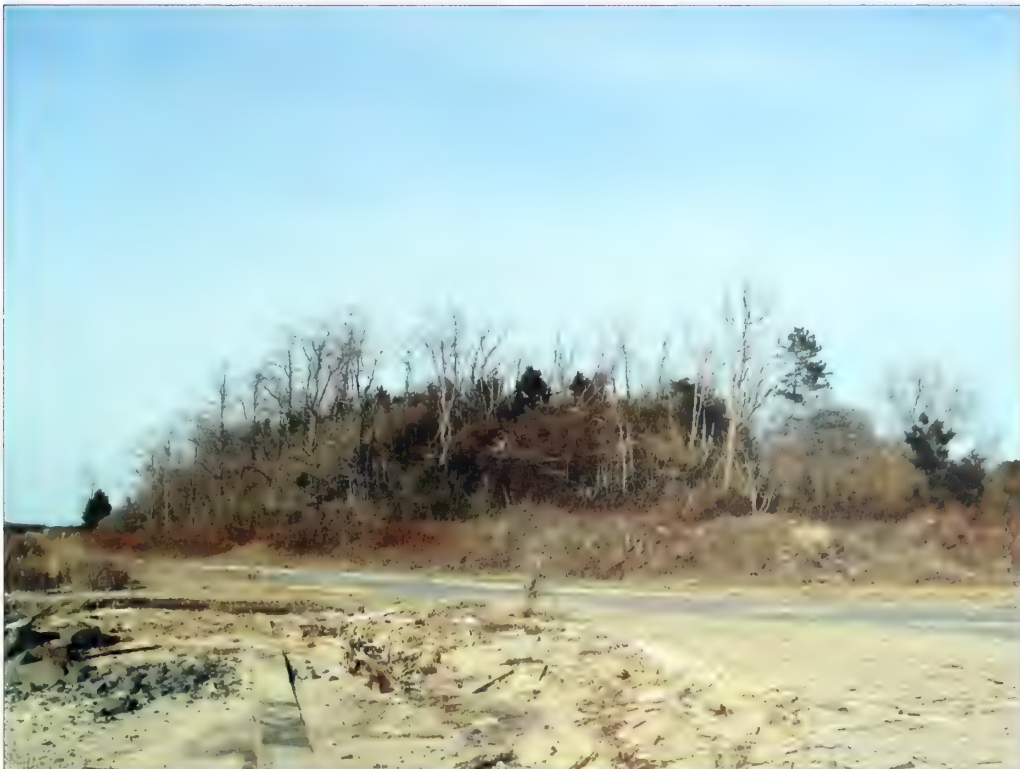
Figure 3.46. View looking northeast at Battery Kingman. The major constructed feature of Batteries Kingman and Mills is the engineered earthwork that rises in stark contrast to the surrounding land (Olmsted Center, January 2009).

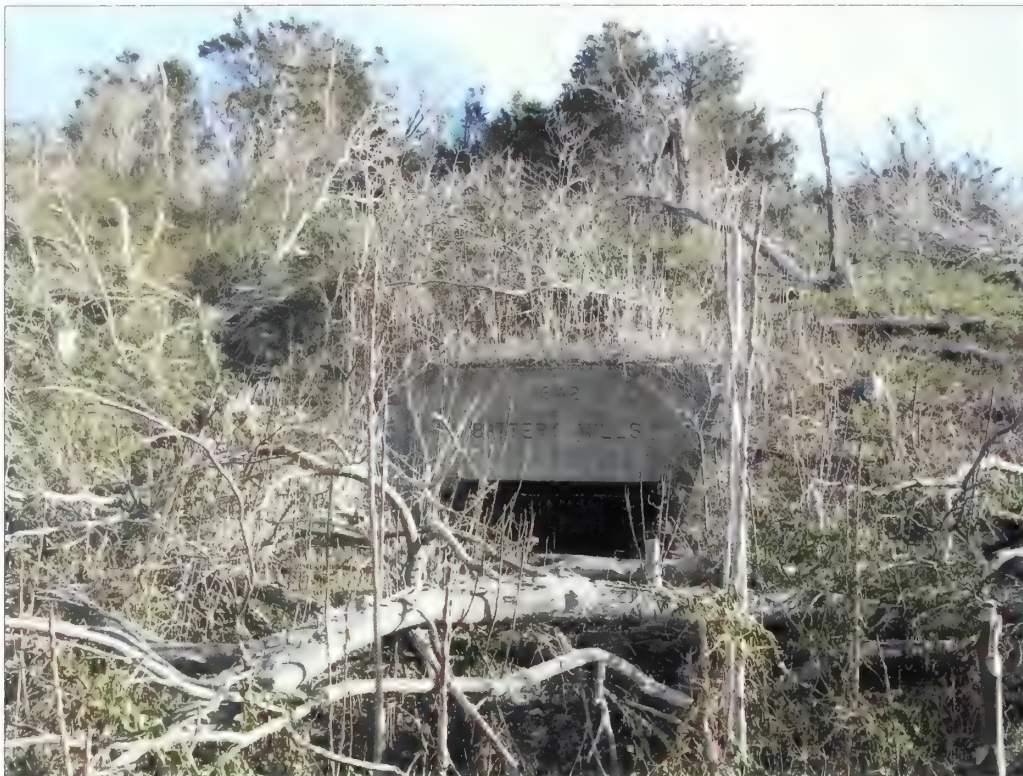
Figure 3.47. View looking east at entry to emplacement #1, Battery Mills. The main entry and entry for emplacement #1 are inaccessible due to the density of woody vegetation (Olmsted Center, January 2009).

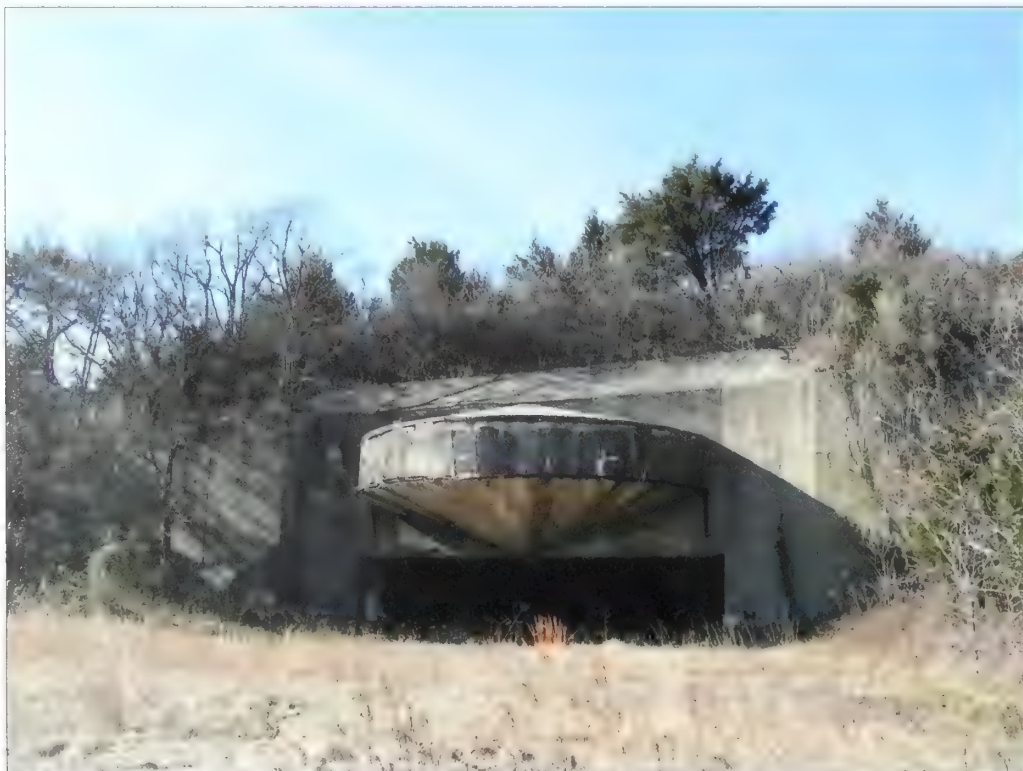
Figure 3.48. View looking southwest at emplacement #2, Battery Kingman. Designed to shield the gun platform from overhead fire, the concrete canopy exhibits efflorescence indicating water is infiltrating the concrete and drawing out impurities to the surface (Olmsted Center, January 2009).
